# A cure for foaming and spill-out in the Melrose oxygenator

R. N. G. ATHERSTONE AND DAVID CHAPMAN

*From The London Chest Hospital, London, E.2*

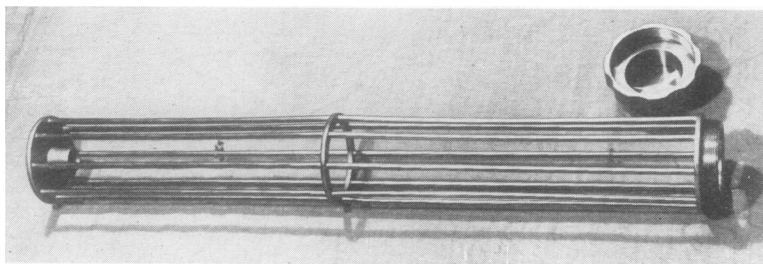
FIG. 1. *Carrier empty*

Immediately after the operation, detailed examination of the oxygenator, trombone assembly, and the arterial filter gave one clue. Blood filmed readily on the outside areas of the trombone tubes, which had originally been smeared with neat M.S. Silicone/Antifoam. Closer scrutiny showed that this film was missing from these areas. By now it was clear that the root cause of foaming in this oxygenator was an insufficient area of M.S.

Silicone/Antifoam on the trombone tubes. Previously it had been our practice to put the prepared trombone assembly in a special linen bag for autoclaving, and on this occasion most of the antifoam film had been rubbed off on the inside of the bag during transport and handling.

We therefore designed the cage container illustrated, which ensures that nothing can touch the antifoam film on the trombone tubes, so that the full antifoam barrier is preserved (Figs. 1 and 2). It is essential that the trombone tubes are separately coated overall with a thin film of undiluted M.S. Silicone/Antifoam and then carefully assembled. For accurate and easy assembly, we use a special jig.
