# Metallurgical analysis of failed Björk-Shiley cardiac valve prostheses

STEVEN H SACKS, MICHAEL HARRISON, PHILIP JE BISCHLER,  
JOHN W MARTIN, JOHN WATKINS, ALF GUNNING

*From the Nuffield Department of Clinical Medicine, John Radcliffe Hospital; Department of Metallurgy and Science of Materials, University of Oxford; and the Department of Cardiovascular Medicine and Surgery, John Radcliffe Hospital, Oxford*

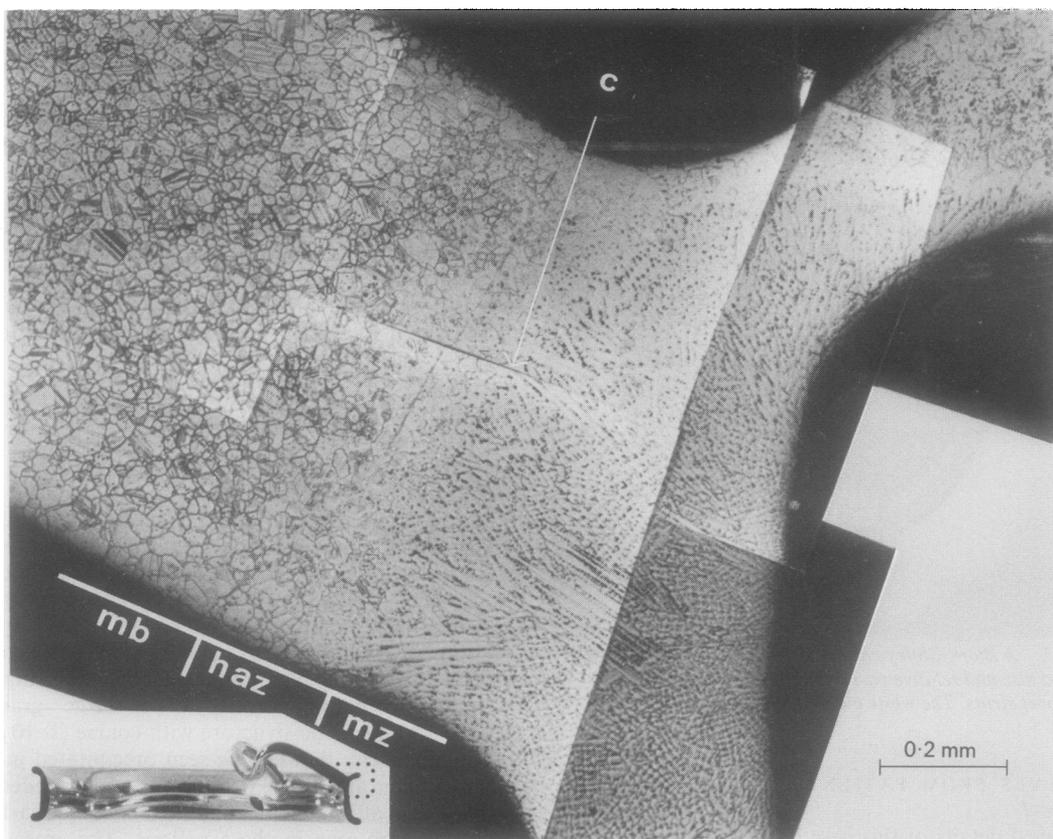
Figure 2 shows a metallographic section of an unused Björk-Shiley valve illustrating the microstructure of the strut-weld region. The main body of the strut contains small ( $\sim 25 \mu\text{m}$ ) equiaxed (that is, roughly spherical) recrystallised grains. The lower and upper sections of the ring show a somewhat coarser grain size ( $\sim 50 \mu\text{m}$ ). The region that was molten during the welding procedure consists of a large grained ( $\sim 250 \mu\text{m}$ ) dendritic structure with coarse ( $1-10 \mu\text{m}$ ) carbide particles that can be seen precipitated in the interdendritic areas. The fusion zone was bounded by narrow heat affected zones and further coarse carbide particles were seen in these regions. The cross sectional area of the strut is seen to be constricted at its root.

Fig 2 Metallographic section through the minor strut, weld, and annulus of an unused Björk-Shiley prosthesis. *mb*—main body of the short strut; *mz*—molten zone; *c*—carbide deposits; *haz*—heat affected zone.

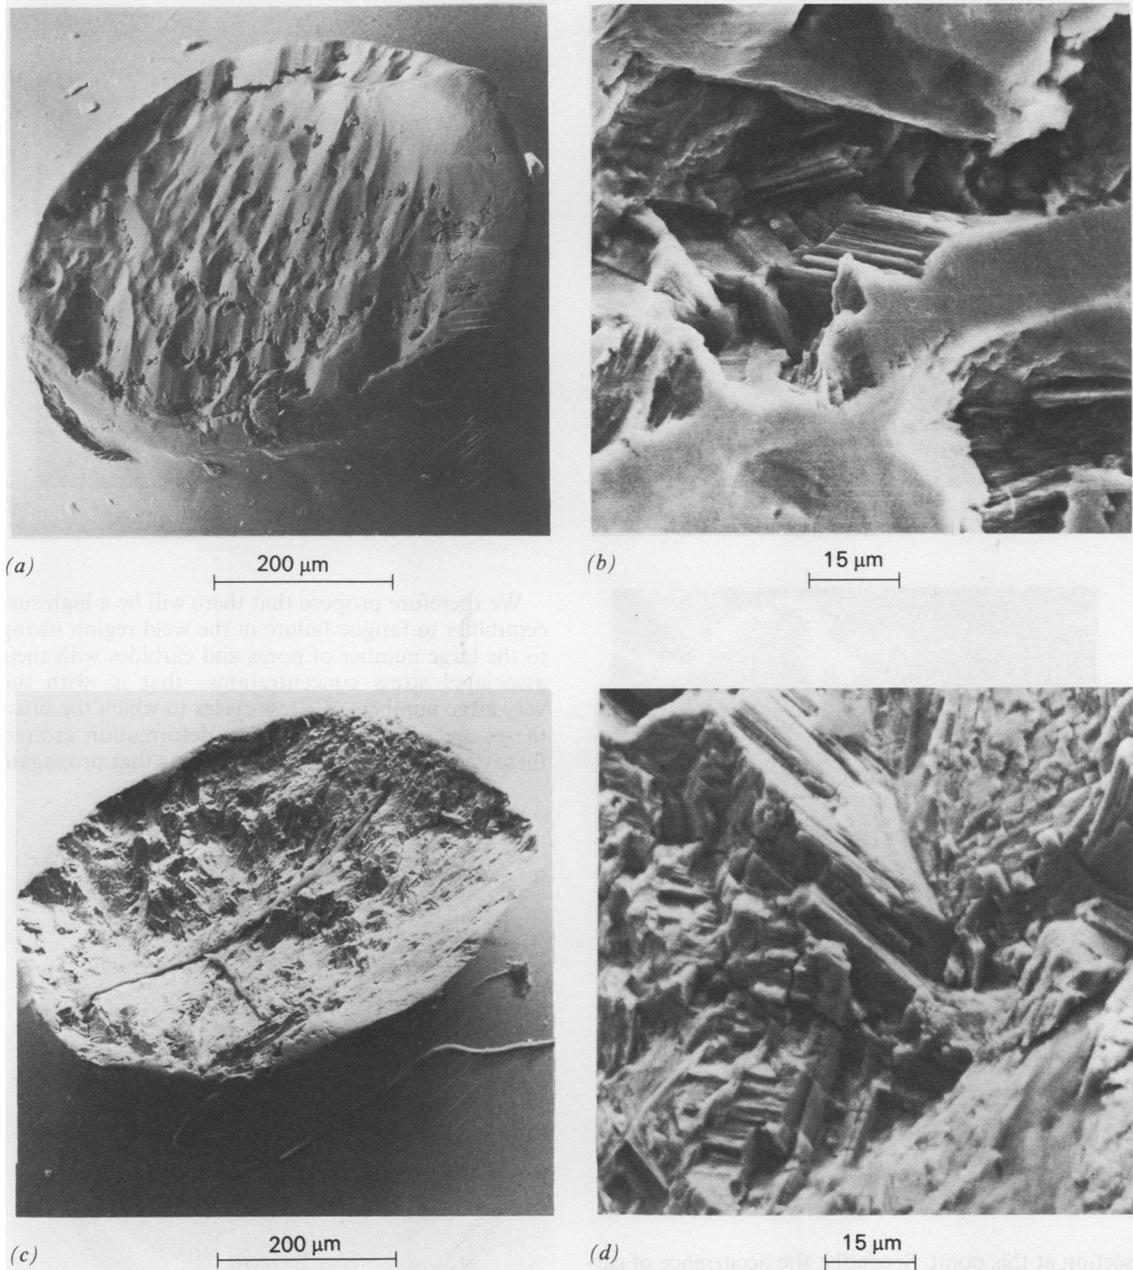
The two fracture surfaces on the valve ring that corresponded to the points of attachment of the short strut were examined by scanning electron microscopy. The first showed a smooth surface with numerous depressions (fig 3a). In these a faceted structure of ledges and striations was seen (fig 3b). By contrast, the second surface (figs 3c and 3d) was entirely covered by the striated structure.

Corresponding features were present on the respective fracture surfaces of the strut. A metallographic section taken through the strut (not shown) verified that failure had occurred through the coarse carbide band at the interface between the weld and the heat affected zone.

**Fig 3** Case 1: Scanning electron micrographs illustrating (a) general view of the first fracture surface on the ring; (b) striations in a depression and "smearing" of the surface due to wear after the fracture; (c) general view of the second fracture surface on the ring; (d) striated structure at high magnification.

Leg 1 of the first fractured strut showed a large area of smooth surface, which is typical of the "smearing" that accompanies wear. This suggests that leg 1 failed before leg 2, and that some considerable time elapsed between failures to allow wear of the opposing fracture surfaces of leg 1. A similar pattern is seen in case 3, where fortuitously the valve was removed before failure of the second leg.

The respective contributions that each microstructural feature has made to the fracture process are still under investigation. Nevertheless, we conclude that this type of failure is clearly related directly to the inhomogeneities in structure that result from the welding process. These problems might be prevented if the whole of the disc supporting structure were manufactured as one piece of metal.

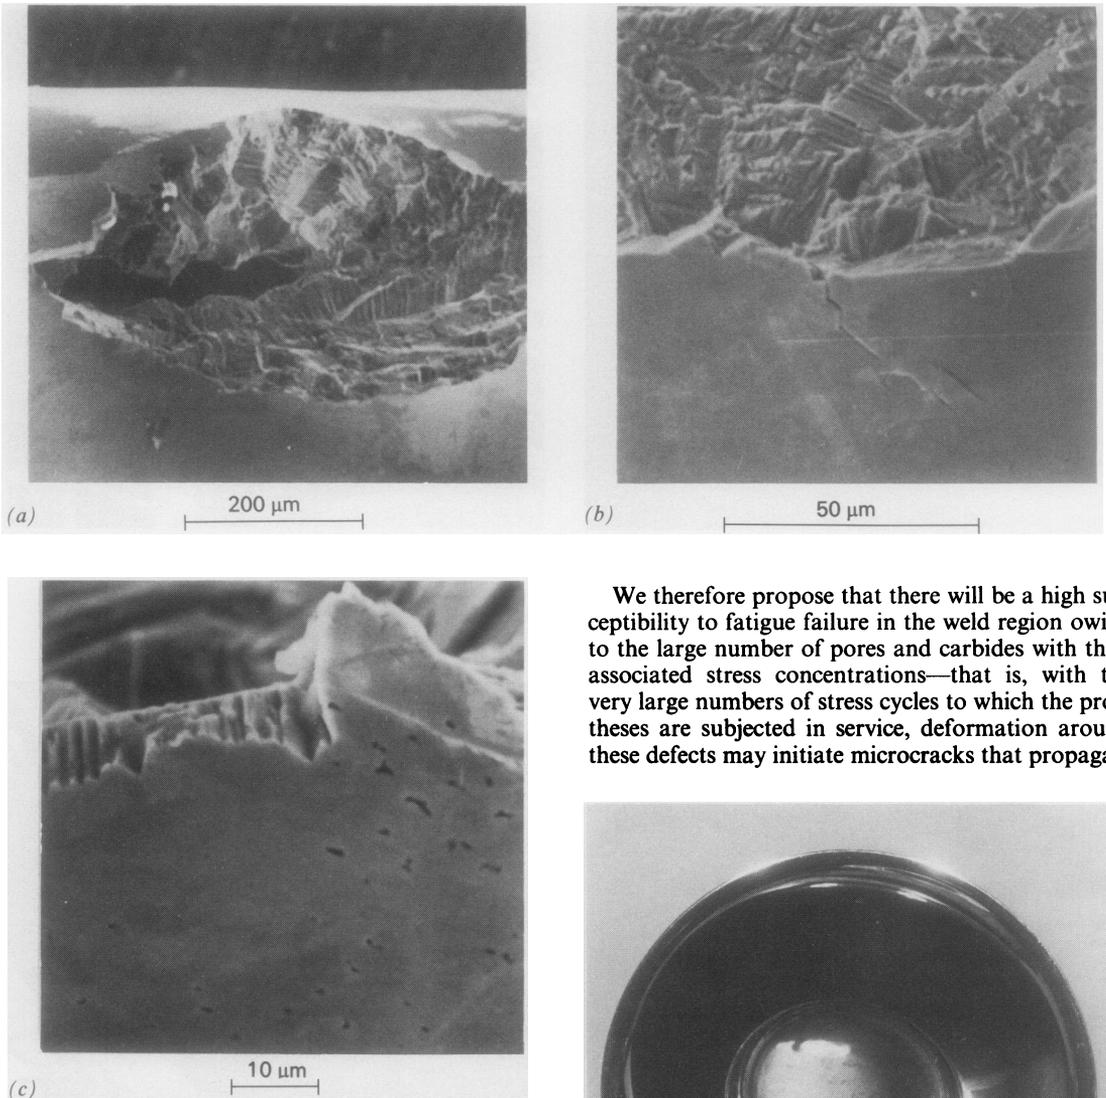
The two fracture surfaces in this case were alike. They were both flush with the ring, failure having occurred in the melt zone of the weld. Both showed large areas

of striated and faceted structure (fig 4a). In this case the fractured strut also took with it part of the ring, leaving sizable holes in the central region of each fracture surface. Extensive cracking and also some porosity was evident around the circumference of each fracture surface (figs 4b and 4c).

**Fig 4** Case 2: Scanning electron micrographs illustrating (a) general view of the fracture surface on the ring; (b) cracking in the weld at the point of fracture; (c) surface porosity in the weld adjacent to the fracture surface.

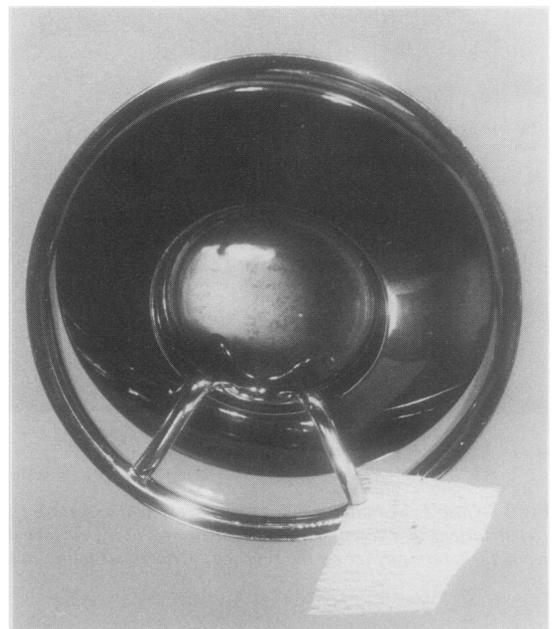
This valve was removed from a patient because of failure in the suturing and was thus nominally unfailed. Examination of the undisturbed structure for evidence of fatigue cracks revealed that one leg of the short strut was completely fractured at the point of welding to the valve ring (fig 5). Furthermore, examination of the root of the second leg showed extensive cracking and porosity over most of the circumference, similar in appearance to that in case 2. A striated structure, of the type described above, was observed on the small portions of the fracture surface that were visible on the broken leg.

**Fig 5** Case 3: Fractured leg of the short strut.
