An unusual complication following replacement of the aortic valve by the Starr-Edwards prosthesis

B. BEDNAŘÍK, K. HOFMANN, O. MEDŘICKÝ,
J. NAVRÁTIL, AND O. OLEJNÍK

From the Second Surgical Clinic, Brno, Czechoslovakia

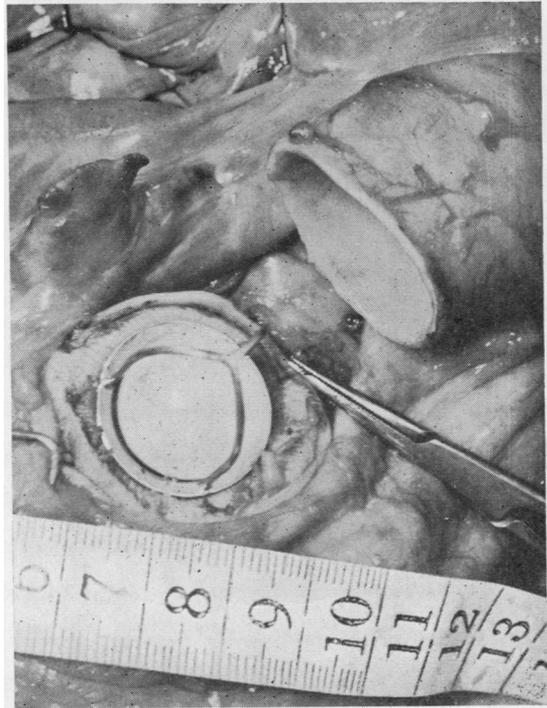
The object of this communication is to describe an unusual complication that occurred during the replacement of an aortic valve in the way described above. There were no unusual features about the clinical condition or the operative technique in the patient concerned. He was a man aged 45 suffering from calcific aortic stenosis. The artificial heart-lung apparatus was used and the valve was sutured into position during extracorporeal circulation. When the operation on the valve had been completed there was some difficulty in resuscitating the heart. The beat was weak and episodes of ventricular fibrillation occurred. It was necessary on several occasions to resume extracorporeal circulation, and eventually pulmonary oedema occurred which was rapidly followed by death. Necropsy revealed that the valve had been sutured into position correctly (Fig. 1). The orifices of both coronary arteries were free and all the stitches had been tied accurately and without a dehiscence. When the left ventricle was opened, however, it was

FIG. 1. *Post-mortem findings. View of the implanted surface from the aortal side.*

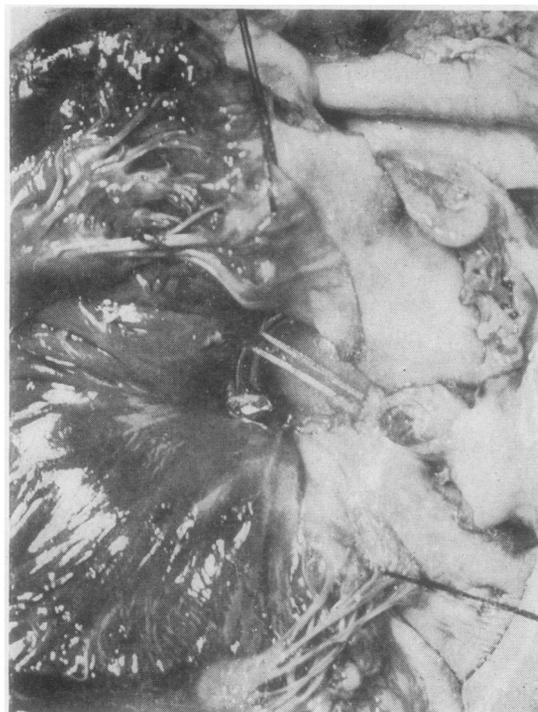
immediately apparent that loops from two of the stitches had passed across the base of the valve, thus preventing the ball from fitting into the cup in diastole (Fig. 2). In diastole there was a gap 2 mm. wide within and around the entire circumference of the prosthesis at its bearing surface, and the result was acute insufficiency. After searching the literature we have not found a similar case. As the result of a careful analysis and reconstruction of the technique we used during the operation we are convinced that bridg-

FIG. 2. *Post-mortem findings. View of the implanted prosthesis from the left ventricle. Stretched across the base of the prosthesis is the stitch fibre which prevented the ball from fitting into the prosthesis saddle in diastole.*

ing of the base of the prosthesis by the stitch can occur at the moment when the prosthesis is inserted into the subcoronary space of the aorta. After the stitches had been passed through the remaining raw edges of the excised cusps and into the teflon cuff of the prosthesis, the latter was inserted into the aorta and the stitches were simultaneously drawn taut in the other direction. The prosthesis was then lowered into the subcoronary space by tightening the stitches. In our patient one stitch remained loose under the prosthesis and formed a loop, the top of which became fixed across the base of the ball. Thus it happened that the ball was thrown in diastole against the taut stitch instead of against its normal setting. At operation we had noticed nothing unusual. We attributed the acute left ventricular failure to primary insufficiency of the hypertrophic and degenerated heart muscle, and also to the fact that during the operation we had not been able to achieve an efficient coronary artery perfusion.
