# An unusual complication following replacement of the aortic valve by the Starr-Edwards prosthesis

B. BEDNAŘÍK, K. HOFMANN, O. MEDŘICKÝ,  
J. NAVRÁTIL, AND O. OLEJNÍK

*From the Second Surgical Clinic, Brno, Czechoslovakia*

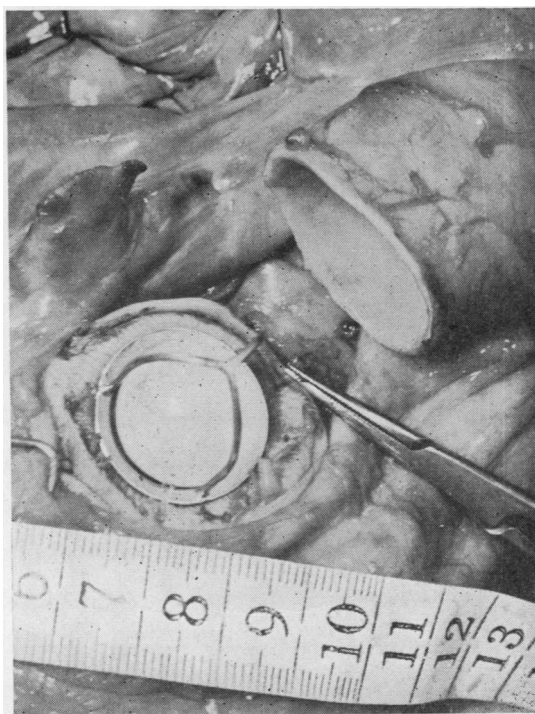
FIG. 1. *Post-mortem findings. View of the implanted surface from the aortal side.*

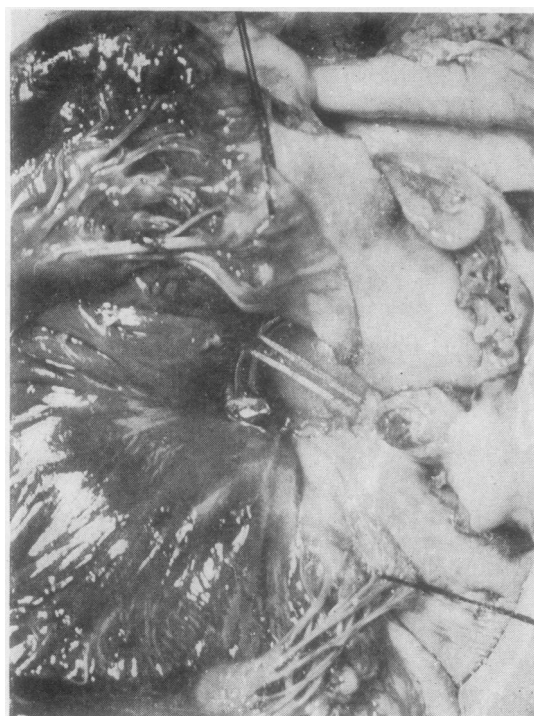
immediately apparent that loops from two of the stitches had passed across the base of the valve, thus preventing the ball from fitting into the cup in diastole (Fig. 2). In diastole there was a gap 2 mm. wide within and around the entire circumference of the prosthesis at its bearing surface, and the result was acute insufficiency. After searching the literature we have not found a similar case. As the result of a careful analysis and reconstruction of the technique we used during the operation we are convinced that bridg-

FIG. 2. *Post-mortem findings. View of the implanted prosthesis from the left ventricle. Stretched across the base of the prosthesis is the stitch fibre which prevented the ball from fitting into the prosthesis saddle in diastole.*

ing of the base of the prosthesis by the stitch can occur at the moment when the prosthesis is inserted into the subcoronary space of the aorta. After the stitches had been passed through the remaining raw edges of the excised cusps and into the teflon cuff of the prosthesis, the latter was inserted into the aorta and the stitches were simultaneously drawn taut in the other direction. The prosthesis was then lowered into the subcoronary space by tightening the stitches. In our patient one stitch remained loose under the prosthesis and formed a loop, the top of which became fixed across the base of the ball. Thus it happened that the ball was thrown in diastole against the taut stitch instead of against its normal setting. At operation we had noticed nothing unusual. We attributed the acute left ventricular failure to primary insufficiency of the hypertrophic and degenerated heart muscle, and also to the fact that during the operation we had not been able to achieve an efficient coronary artery perfusion.
