# Metallurgical analysis of failed Björk-Shiley cardiac valve prostheses

STEVEN H SACKS, MICHAEL HARRISON, PHILIP JE BISCHLER,  
JOHN W MARTIN, JOHN WATKINS, ALF GUNNING

*From the Nuffield Department of Clinical Medicine, John Radcliffe Hospital; Department of Metallurgy and Science of Materials, University of Oxford; and the Department of Cardiovascular Medicine and Surgery, John Radcliffe Hospital, Oxford*

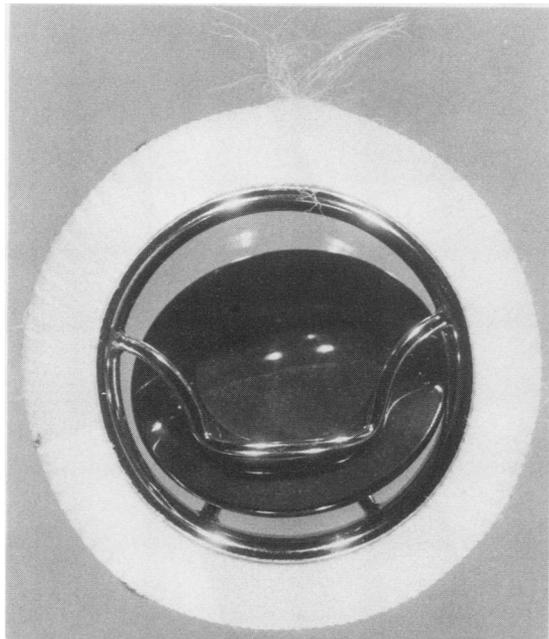
Fig 1 A Björk-Shiley cardiac valve prosthesis showing the tilted disc and relative position of major and minor disc support struts. The white outer sleeve is the sewing ring.
